SERVICE INFORMATION LETTER

FROM: JetProp LLC

1 May 2003

SUBJECT: Tail Cone Inspection

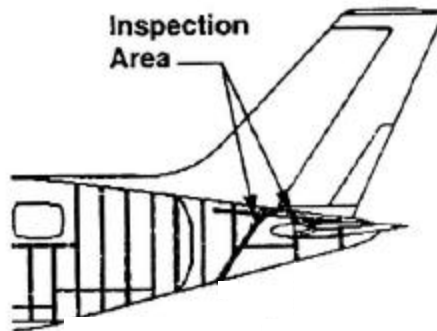
Figure 1

Background. We have identified aircraft arriving for the JetProp conversion (prior to beginning the conversion) with working rivets in the tailcone section, and several with loose tail attachment bolts. In addition, it has come to our attention that two of the JetProps have exhibited the same working rivets and loose tail attachment bolts which may have started prior to, or post, conversion. As a safety precaution we are asking each JetProp owner to make sure that the following inspection on the tail is performed by the owner's maintenance facility.

1. Inspect the aircraft tail cone in the area of the horizontal stabilizer (See Figure 1) for "working" rivets. These can usually be identified by cracked paint around the rivet heads and/or trailing dark smear markings. If working rivets are identified, replace as necessary.
2. Inspect and torque the horizontal stabilizer attachment bolts and the vertical fin attachment bolts (Per Piper Maintenance Manual torque specifications).
3. Make a logbook entry indicating compliance with this service letter.
